State Historic Preservation Office

Reviving a Greek Revival Traditional Plaster and Limewash Restoration on a Lower Garden District Mansion

By Liz Russell, Project Officer
Historic Building Recovery Grant Program

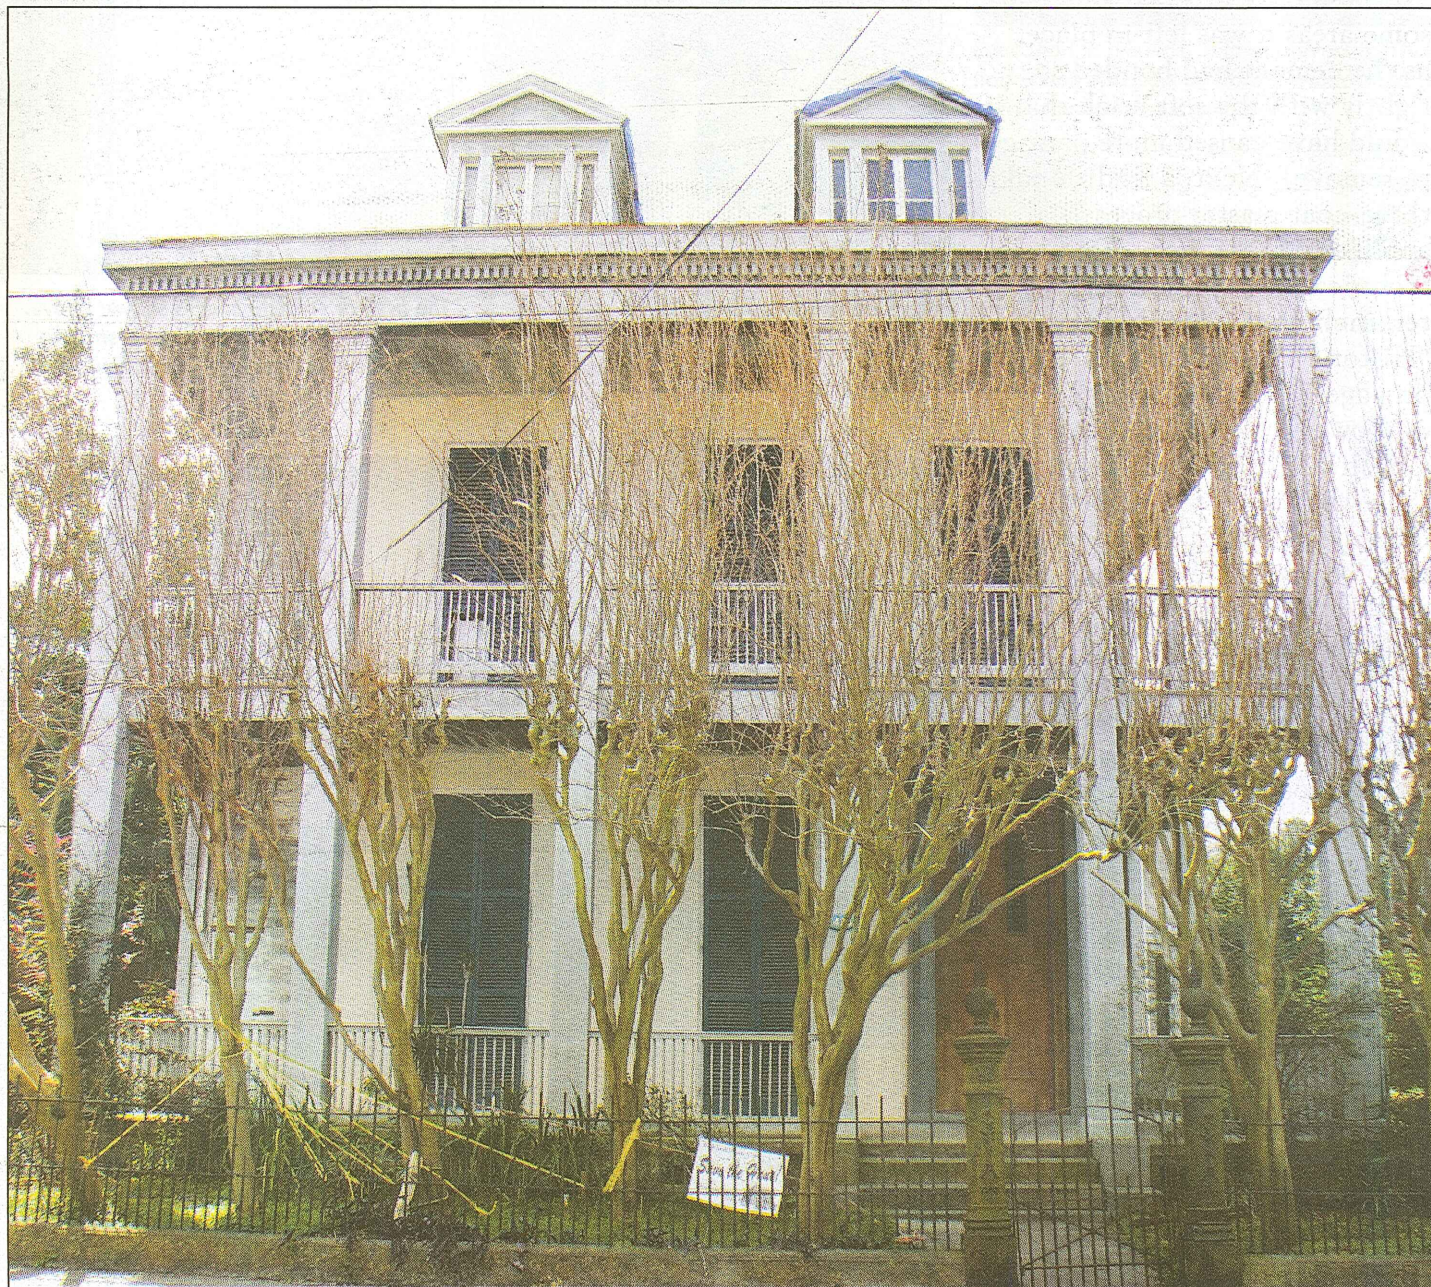
Built in 1846, and occupied by Union Soldiers during the Civil War, 1420 Euterpe St. later served as home to the New Orleans Freedmen's Bureau. In 2007, the house received traditional plaster repair and limewash application made possible with funds from the Historic Building Recovery Grant Program.

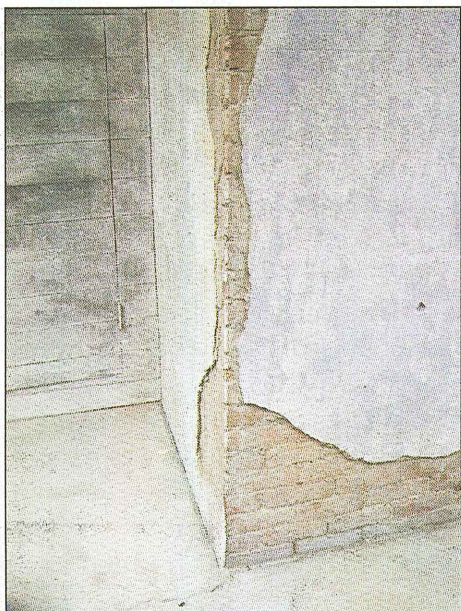
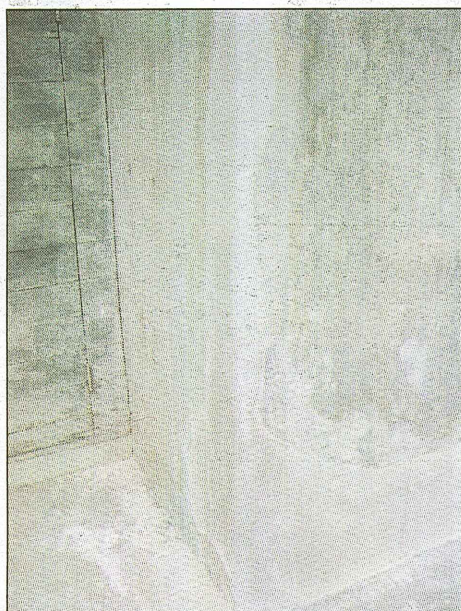
Corner of house after removing damaged plaster (above) and after receiving three coats of plaster (below). The gray coloring of the patch indicates that the plaster is still drying. Slow drying prevents cracks in the plaster. The discolorations in original plaster are a result of a modern aluminum paint that was applied in the 1950s. The house received several treatments of a gentle, peroxide-based Cathedral Stone® paint stripper, but some stains still remain. Incompatible with plaster, impermeable paint must be removed before limewashing, enabling the limewash to properly adhere to the plaster.

part in the degraded condition of the exterior plaster. In many areas, layers of plaster were flaking and falling away from the bulging and disintegrating brick courses. Repairs dating from the 1940s were severely compromising the plaster on the house. The rigid Portland cement patches, including a one-foot band along the base of the house, were incompatible with softer lime-based plaster, and added to moisture damage due to the rising damp.

Using documentation and scientific analysis, Heather Knight and her team of students and conservation assistants employed traditional methods and materials to restore the exterior fabric of the house. They began by removing loose and damaged plaster and taking out as much Portland cement as possible (in some areas it was left in place, as the cement had bonded so tightly with the soft brick that it would have caused more damage to remove). Next, a traditional three-coat plaster process was applied to these areas. For more technical information on plaster, including its application, see “Historic Plaster Exposed,” found on page 7. The entire northern lower gallery wall received a fresh covering of plaster, and then was scored to resemble natural stone. Finally, the main body of the house received five coats of hand-pigmented warm yellow ochre limewash, just as the house received when it was built in 1846. The budget parameters of this project only allowed for five coats. However, with annual limewashing, the Costas will be able to achieve the ideal eggshell protective coating that the plaster needs and the uniform color that they desire.

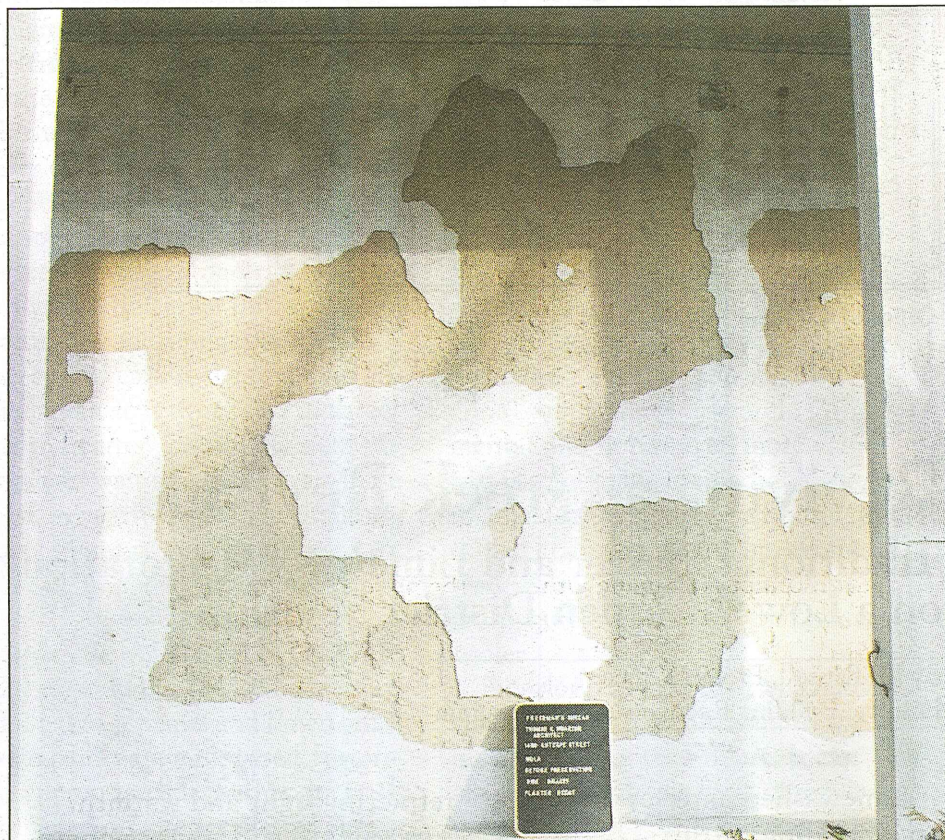
Northern lower gallery wall before plaster repairs and limewash.

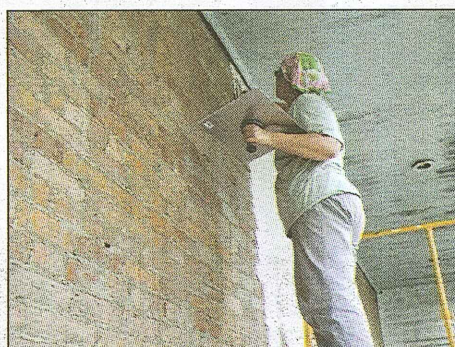
Northern lower gallery wall during plaster repairs and limewash. Here, Knight is applying the first, or scratch, coat to the masonry.
